# An Analytically Validated Highly Damped Repair for Acoustically - Induced Cracking on the F/A-18 Nacelle Skin

S.C Galea and R.J.Callinan

DSTO-TR-1162

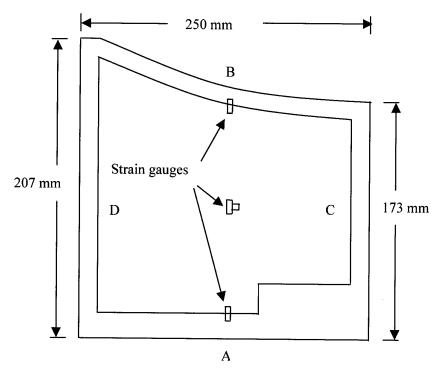
Figure 11. Location of strain gauges on right hand nacelle panel [1].

Strain gauge flight data have been obtained for the F/A-18, [1], using single gauges on the edge of the panel and a strain gauge rosette shown in Fig. 11. Specifically these locations correspond to regions of high strain. A finite element model representing the double curvature of the skin panel was developed corresponding to the outline shown in Fig. 11. This model was calibrated by adjusting the curvature such that very close results were obtained for the first three mode shapes and frequencies. The power spectral density defined in Table 1 was used as the excitation condition in this case.

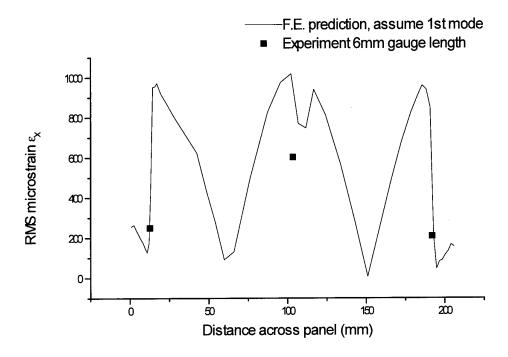
The *rms* strain results shown in Fig. 12 represent a traverse on the outside skin from point A to B, while in Fig. 13 the results correspond to a traverse from point C to D. The high strain gradients at the edge of the panel are due to the step change in panel thickness due to chemical milling. As such it is difficult to assess the accuracy of these results except that the F.E. analysis appears to be conservative. The complexity of this F.E. model was such that to carry out parametric analysis was very time consuming and as a result flat panel models were considered instead.

Figure 12. Strain distribution along line from points A to B, see Figure 11.

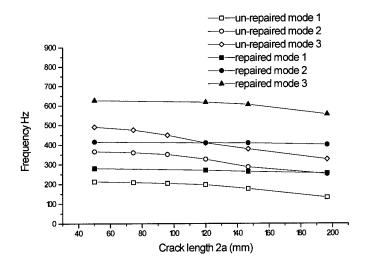
Figure 15. Frequency versus crack length for un-repaired and repaired cases.

Shown in Fig. 15 are the natural frequencies versus crack length for the cracked unrepaired panel and also the cracked repaired panel for the first 3 resonant modes. In the case of the cracked unrepaired structure, increasing the crack length significantly reduces

the resonant frequencies of the panel. Also as expected, repaired panels have little variation in natural frequencies with crack length. Furthermore, the repaired panels have substantially higher natural frequencies for all modes than the un-repaired panels. The boron repair has a definite influence on the panel stiffness.

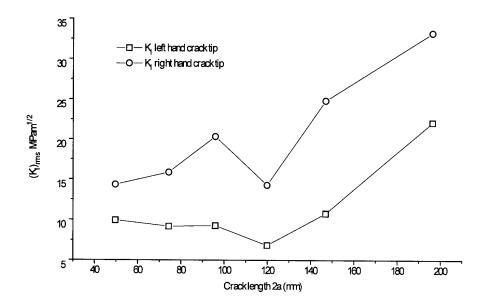
The rms mode I stress intensity factor  $(K_I)_{rms}$  for the cracked un-repaired panel is shown in Fig. 18a. As expected, the general response is an increase of  $(K_I)_{rms}$  with crack length. The

left hand crack tip is always closer to the clamped edge of the panel than the right hand crack tip, and since the bending stresses are a maximum midway along the boundary, the right hand tip gives the highest value of  $(K_I)_{rms}$ . The values of  $(K_I)_{rms}$  in relation to the fracture toughness, are significant and explain crack growth. For crack growth, threshold values of  $(K_I)_{rms}$  are shown in Fig. 31.

Figure 18 (a) Stress intensity factor  $(K_I)_{rms}$  in un-repaired panel for left and right hand crack tips

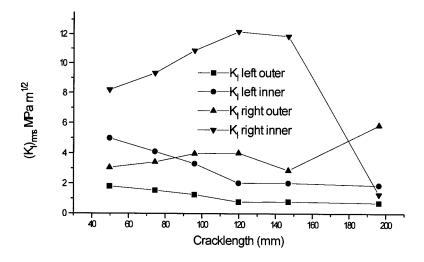
In the repaired panel the neutral axis is offset and as a result  $(K_I)_{rms}$  is evaluated at both inner and outer surfaces of the skin; the repair being applied to the outer surface. Being a one sided repair the repair is more effective on the outer surface which is more closely restrained [6]. These bending effects are clearly shown in Fig. 18b. The right hand crack results in the highest values for  $(K_I)_{rms}$  located on the inner surface. These values of  $(K_I)_{rms}$  are significantly high before the crack grows out from under the patch and explain continued crack growth. For a normal 'static' repair in which the only significant events are manoeuvre and gust loads, the repair would be successful. However, in the acoustic excitation environment, the resonant frequency of the actual nacelle panel is of the order of 300-400Hz thus causing the repair to be ineffective.

Figure 18 (b) Stress intensity factor  $(K_I)_{rms}$  in repaired panel. (Note the change in scale.) The rms mode II stress intensity factor,  $(K_{II})_{rms}$  for the cracked un-repaired panel is shown in Fig. 19a. Little through thickness variation of  $(K_{II})_{rms}$  has been found, hence values are only

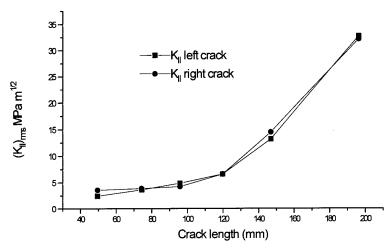
presented for each crack tip. Numerical values are similar to  $(K_{II})_{rms}$  and the existence of  $(K_{II})_{rms}$  explains the tendency of long cracks to turn into the centre of the panel. For the case of the repaired panel shown in Fig. 19b,  $(K_{II})_{rms}$  has been substantially reduced.

Figure 19 (a) Stress intensity factor  $(K_{II})_{rms}$  for un-repaired panel.

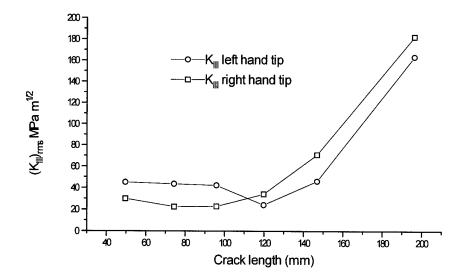
Figure 20 (a) Stress intensity factor  $(K_{III})_{rms}$  for un-repaired panel.

The rms of mode III stress intensity factor  $(K_{III})_{rms}$  for the cracked un-repaired panel is shown in Fig. 20a. The values of  $(K_{III})_{rms}$  increase significantly with crack length for both left and right hand crack tips, and the numerical value of  $(K_{III})_{rms}$  is greater than  $(K_I)_{rms}$ . Clearly  $(K_{III})_{rms}$  will contribute significantly to crack growth. In the case of the repaired panel, shown in Fig. 20b, the values of  $(K_{III})_{rms}$  for a crack tip under the patch are low, but not zero. However, once the crack grows outside the patch (i.e. for crack lengths > 120 mm)  $(K_{III})_{rms}$  increases significantly.

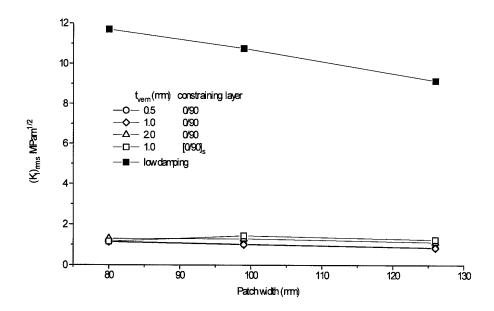
Stress intensity factors are computed at the inside and outer surfaces of the skin. Since the repair results in a neutral axis shift the maximum values exist at the inner surface. The most critical crack tip position is the tip located midway down the longest side of the panel, as shown in Fig. 14. The maximum values have been plotted in Figs. 27, 28, 29 and 30. Various highly-damped patch configurations, involving 0.5, 1.0 and 2.0 mm thick damping VEM, are considered. In all cases the highly-damped patch has a boron/epoxy reinforcement/repair with dimensions 77 mm long and varying widths of 80 mm, 99 mm and 126 mm. Over the range of damping thickness considered the configuration that give the lowest values of  $(K_I)_{rms}$  is for the 77 mm long by 126 mm wide reinforcement/repair with the 1.0 mm thick VEM and [0/90] constraining layer case. Also, the 0.5 mm thick VEM with [0/90] constraining layer case gave similar stress intensities as shown in Fig. 28.

Figure 27. Stress intensity factor,  $(K_I)_{rms}$ , for various highly-damped and low damped patch configurations.
